# **Compliance and Implementation Monitoring of Forestry Best Management Practices for Harvesting in South Carolina, 2004-2005**

## **Best Management Practices Monitoring Report BMP-6**

Published by the South Carolina Forestry Commission,  
Columbia, SC July 2006

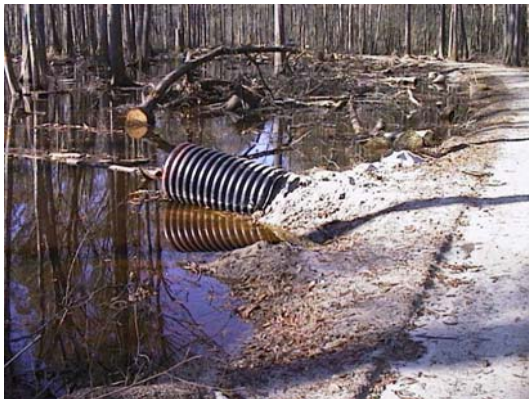
*Example of improper culvert installation.*

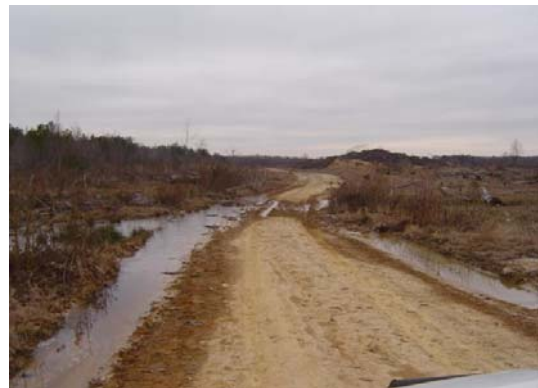
*Ephemeral stream flow is blocked by this road.*

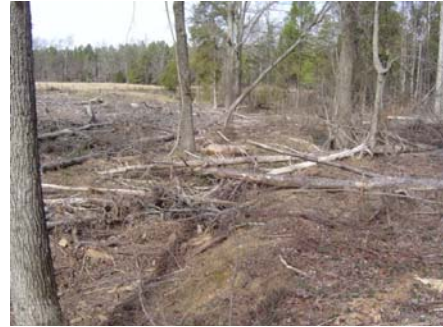
*Excessive debris in an intermittent stream.*

A total of 1,481 individual practices relative to streamside management zones were evaluated with 96.1% implementation. Five sites were noted for significant risk due to retaining less than 50 square feet of overstory basal area within the SMZ, emptying of road runoff into ephemeral areas, and failure to keep tops and other logging debris out of stream channels.

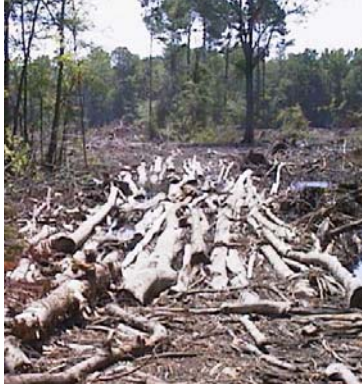
*A skid trail debris crossing.*

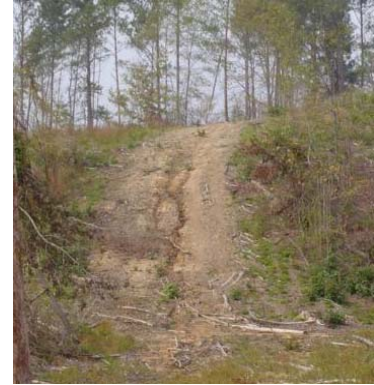
Five sites were rated as inadequate primarily because of failure to stabilize skid trails and skidding or blockage of ephemeral areas.

*A poorly stabilized skid trail.*

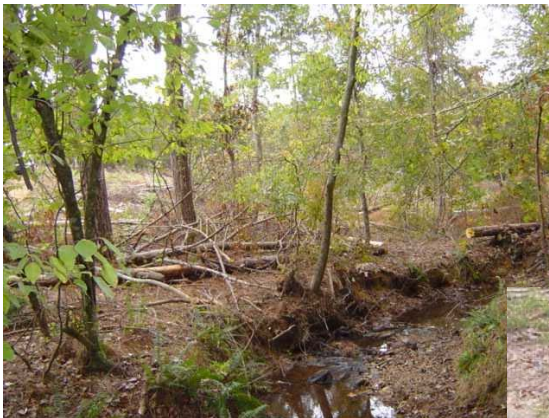
Perennial or intermittent streams were present and streamside management zones were necessary on 130 of the 200 sites included in this monitoring survey. Appropriate SMZs were retained on 125 of those sites. Five sites were rated as inadequate because of harvested SMZs, or excessive harvesting within the SMZ.

*Left: Example of an inadequate streamside management zone.*

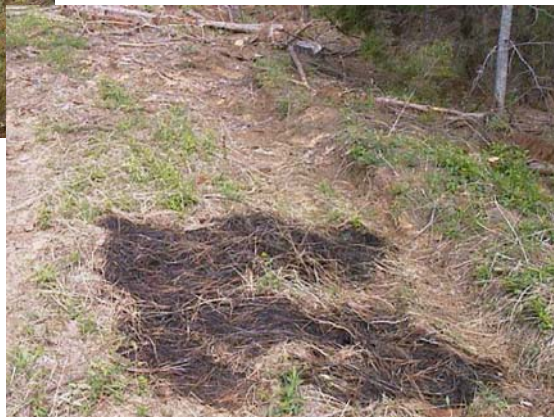
Two of the four sites with inadequate overall compliance failed in the categories of both Streamside Management Zones and Harvesting Systems. The remaining sites with inadequate overall compliance failed in one category each; one in Road Stream Crossings and the other in Harvesting Systems for an oil/hydraulic spill. Specific deficiencies in BMP compliance on sites that were rated as inadequate include:

*Right: Oil spill on a logging deck.*
